NDT DAMAGE DIAGNOSIS ON SANDSTONE – Case Study of Gelnhausen, Germany

Abstract:

The Kaiserpfalz in Gelnhausen, Germany, was built in Romanesque period in sandstone. The widely known palatinate castle was chosen as study case to prove low impact and non destructive techniques for the state evaluation of historic natural stone building material. The locally quarried middle grained sandstone has a bright red colour. On several masonry blocks and architectural elements formation of subsurface detachment is a serious problem. To detect and locate the damaged areas two non-destructive testing procedures were applied and compared. IR-thermography was applied in active and passive procedure. Additionally acoustical investigation was conducted by discreet dragging a metal ball over the surface of the stone and interpreting the sound. Results were drawn into a mapping. The results were transferred to photographs and compared to the mapping. The outcome of the study presents interesting results of the diagnosis of invisible damage at risk on historical building stone.

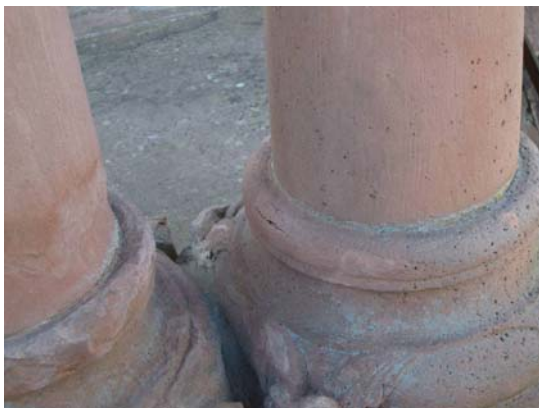
The sandstone Base No 3 shows in some parts pits looking like an enlargement of the natural porosity (Fig.2). On the upper roll moulding of the base a blistering was observed, following the stone deterioration terminology recommended by Vergès-Belmin et. al (2008). Active IRT (Fig. 3) showed that the detachment is traceable and does not exceed the visible damaged area. The thermogram is given as difference-temperature; solely the temperature difference to the temperature distribution at the start of the investigation is shown. This neglects temperature irregularity present at the beginning of the investigation. Interpretation of the thermogram is made difficult due to the three-dimensional structure of the part investigated. Overhanging slim parts heat up faster than massive parts

Figure 2: Base No 3 (right).

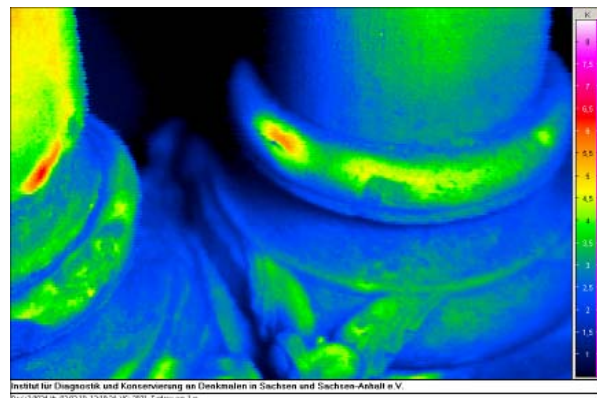
Figure 3: Active IRT on Base No 3.

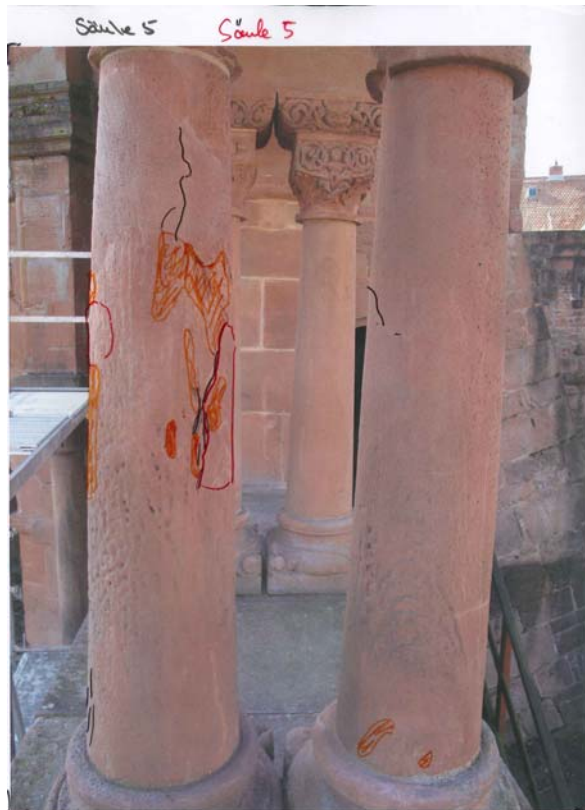
On pillar No. 5 (Fig. 4) active IRT was conducted. The pillar shows differential erosion and alveolisation in its lower parts. Previous typical damage investigation assumed subsurface detachments in the middle part of the pillar. This part was taken for specified investigations. Heater was placed normal to the central part of the pillar at a distance of 1.3 m for 300 s. Every 5 s IR-thermogram was captured. The total measurement sequence covered the activation and the cooling phase of the area investigated (Fig. 5, 6). Also here interpretation was done on the difference-temperature-thermograms.

Figure 4: Pillar 5 (left), previous damage mapping, suspicion of subsurface detachment areas.

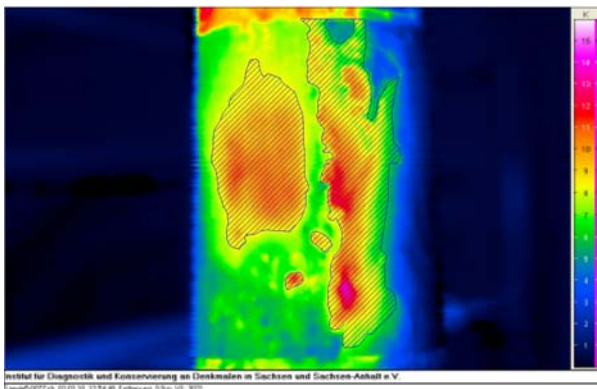
From both investigation phases, activation and cooling, thermograms were taken as basis for interpretation. Thermal anomalies were interpreted as detachment areas and hatched. In comparison to the previous damage mapping (Fig. 4) the IRT damage detection yields high correlation to the detachment area on the right hand side of the pictures (Fig. 5, 6). On the left hand side, divided by the vertical crack, a subsurface detachment was detected, which was not detected before.

Figure 5: Thermogram of the end of heating sequence, detached areas are hatched.

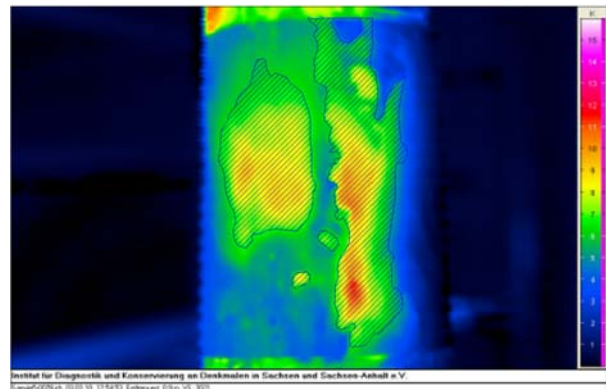
Figure 6: Thermogram during the sequence, detached areas are hatched.

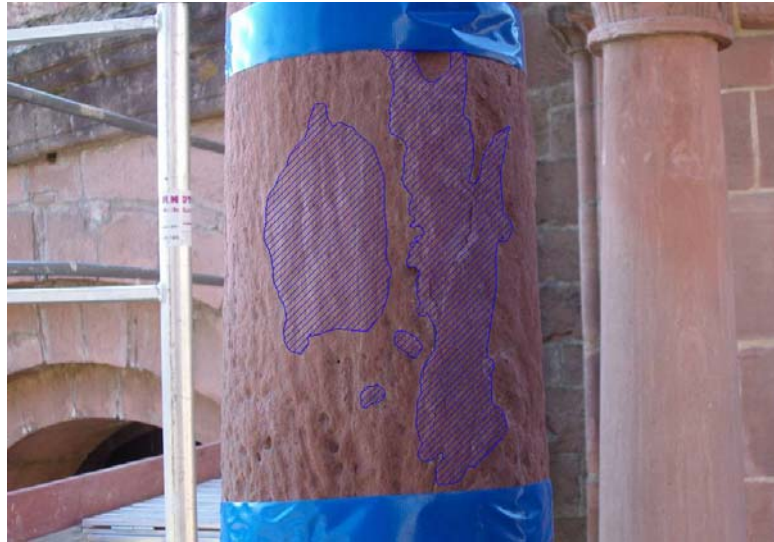
Figure 7: Results of IRT mapping drawn into the photograph.

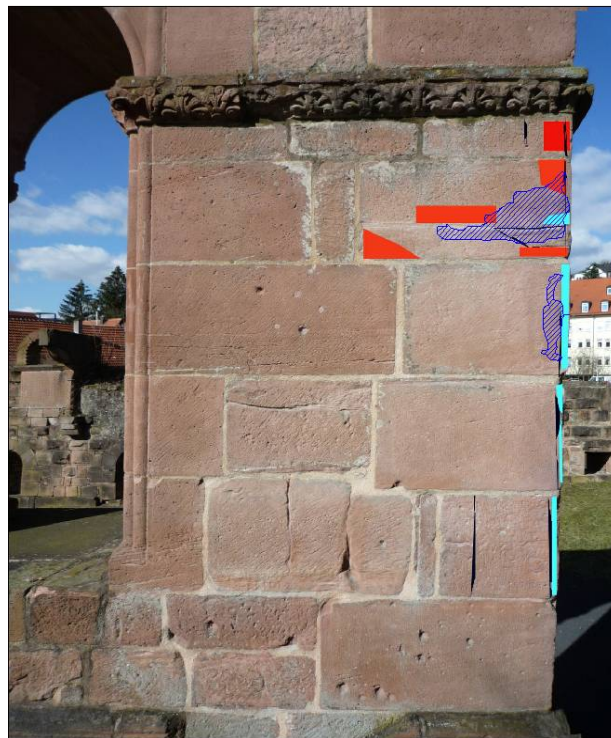
On the eastern pylon passive IRT was proceeded. From investigation with the acoustic Lehrberger Kugel detachments at the sandstone squares was known. In Fig. 8 these areas are given in red colour. IRT was proceeded when the sun was shining on the masonry. Areas of detachment were clearly visible due to temperature anomalies on the surface (Fig. 9). These results were transcribed into the foto (Fig. 8). The challenges in consistency between the two procedures have to be discussed.

Figure 8: Eastern pylon with damage of resonance sound detector (red) and damage detection by IRT (hatched blue).

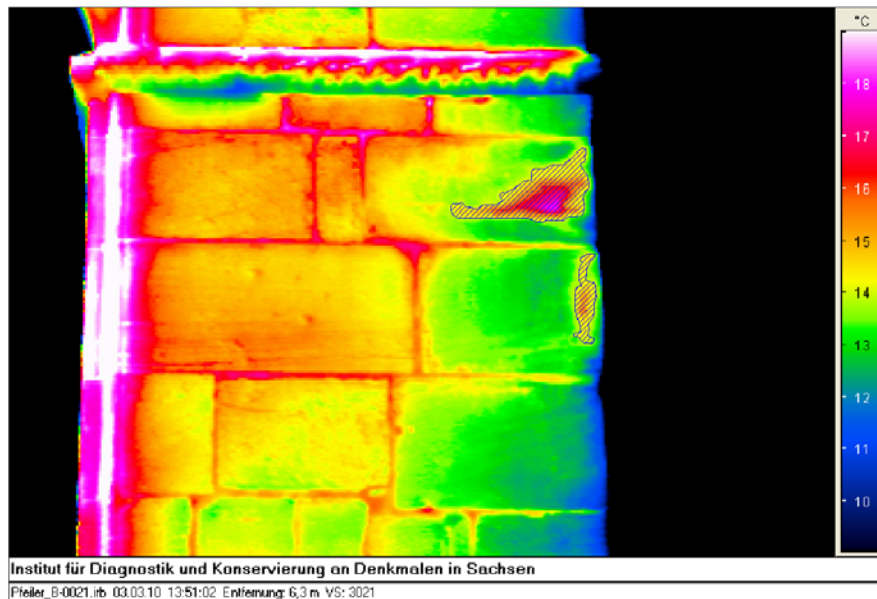
Figure 9: Passive IRT on eastern pylon, damage areas hatched.
